COMMONWEALTH OF PENNSYLVANIA
DEPARTMENT OF ENVIRONMENTAL PROTECTION
OFFICE OF OIL AND GAS MANAGEMENT

**INSPECTION REPORT
ROUTINE**

DEP Office	Scranton Oil & Gas Office	Telephone No.	Permit or Reg. No.	37-115-20043
Address	321 Spruce Street, Suite 300	Fax No.	Project No.	Well Pad: COSTELLO J PAD 2
	Scranton, PA 18503-1418		Farm Name and Well No.	COSTELLO 2
Operator Name	CABOT OIL & GAS CORP		County	Susquehanna
Address	2000 PARK LN		Municipality	Dimock Township
	PITTSBURGH, PA 15276-0130		Latitude (DD)	41.72831
Telephone No.	OGO No. OGO-10897	Client ID No.: 43513	Longitude (DD)	-75.88529
Drilling Rig / Type	No rig on location at time of insp.	Facility	Single-Well Pad

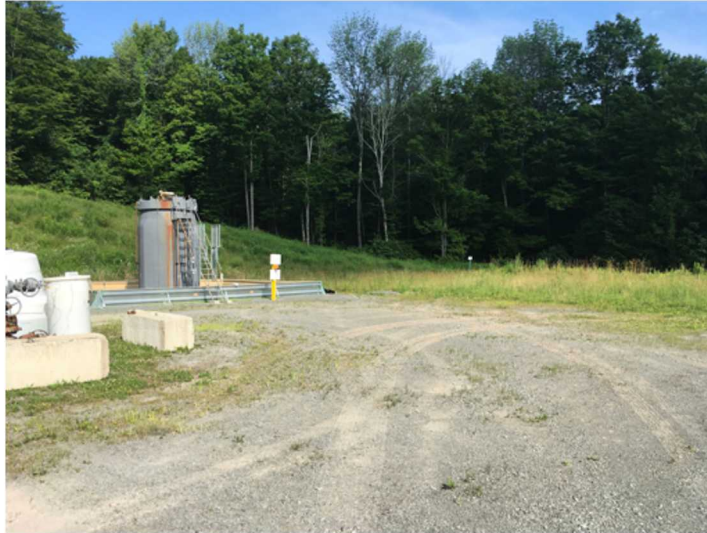
image1530900324184.png

Photo #1. Truck tire tracks indicating Vac Trucks common route to back into remove produced water and rain water from secondary containment.

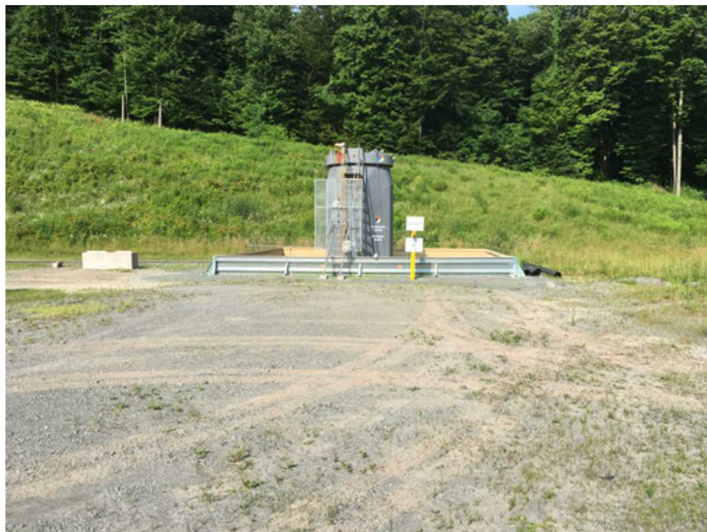
image1530900324529.png

Photo #2. Truck tire tracks indicating Vac Trucks common route to back into remove produced water and rain water from secondary containment.

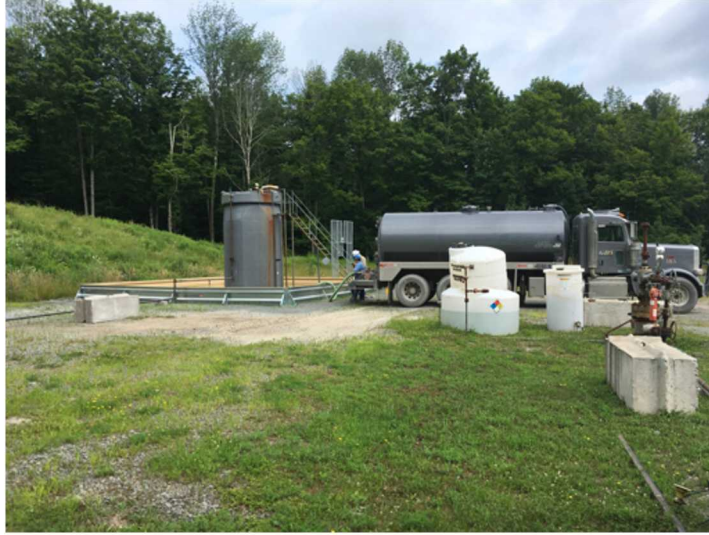
image1530900324894.png

Photo #3. GDS truck actually arrived on location to remove accumulated rain water from secondary containment around Production tank.
